Stoney Brook HOA
Denver, CO

Report #: 10544-0
Beginning: January 1, 2022
Expires: December 31, 2022

RESERVE STUDY
"Full"

January 26, 2022

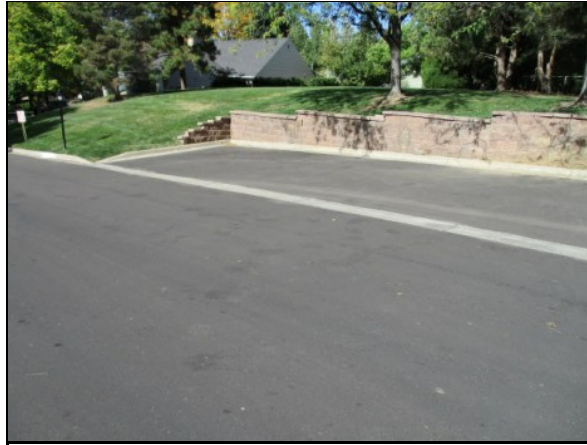
Comp #: 21190 Asphalt - Seal/Repair**Quantity: ~ 281600 GSF**

Useful Life:
4 years

Remaining Life:
3 years
