Stoney Brook HOA
Denver, CO

Report #: 10544-0
Beginning: January 1, 2022
Expires: December 31, 2022

RESERVE STUDY
"Full"

January 26, 2022

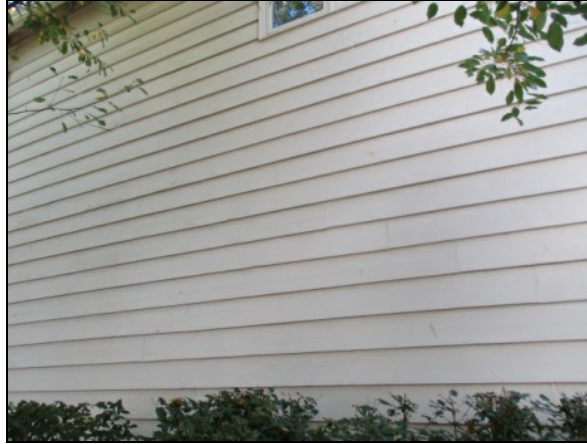
Comments: Client currently paints exteriors of residential units on an 8-year cycle. Components 23300-23308 include the funding for the paint cycles. Painted exterior surfaces determined to be in poor condition typically exhibit clearly noticeable aesthetic concerns such as heavy chalking staining fading inconsistent color and texture etc. Physically paint/coatings in poor condition may be peeling and cracking in many locations may no longer be adhering properly to the painted surface or otherwise are otherwise no longer providing effective protection to the structure.

As routine maintenance, inspect regularly (including sealants), repair locally and touch-up paint as needed. Typical paint cycles can vary greatly depending upon many factors including type of material painted, surface preparations, quality of material, application methods, weather conditions during application, moisture beneath paint, and exposure to weather conditions. Proper sealant/caulking is critical to preventing water intrusion and resulting damage to the building structure. Incorrect installations of sealant are common, and can greatly decrease its useful life. Inspect sealant, more frequently as it ages, to determine if it is failing. Typical sealant problems include failure of sealant to adhere to adjacent materials and tearing/splitting of the sealant itself. As sealants age and are exposure to ultra-violet sunlight, they will dry out, harden, and lose their elastic ability. Remove and replace sealant as signs of failure begin to appear. Proper cleaning, prep work, and proper installation are critical for a long lasting sealant/caulking. Do not install sealant in locations that would block water drainage from behind the siding. Repair areas as needed prior to project. For best results, the client may want to consult with a building envelope specialist or waterproofing contractor to specify types of materials to be used and define complete scope of work before bidding. Best practice is to coordinate this type of work with other projects whenever practical, such as balcony sealing, planter waterproofing, etc.

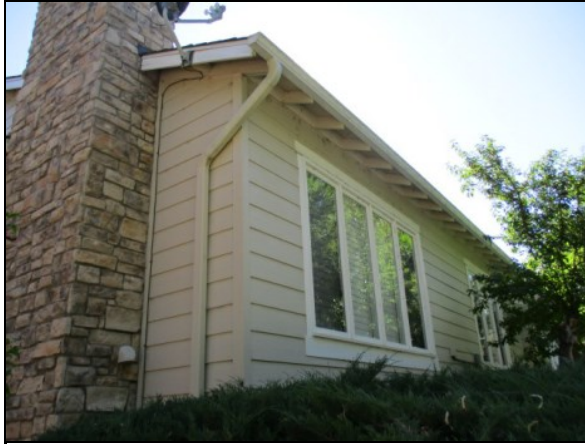
Comments: Client currently paints exteriors of residential units on an 8-year cycle. Components 23300-23308 include the funding for the paint cycles. Painted exterior surfaces determined to be in fair condition typically exhibit some minor to moderate signs of wear and age such as chalking peeling blistering etc. Problems tend to develop in more exposed areas first. Hairline cracks may be present at this stage. Overall appearance is satisfactory.

As routine maintenance, inspect regularly (including sealants), repair locally and touch-up paint as needed. Typical paint cycles can vary greatly depending upon many factors including type of material painted, surface preparations, quality of material, application methods, weather conditions during application, moisture beneath paint, and exposure to weather conditions. Proper sealant/caulking is critical to preventing water intrusion and resulting damage to the building structure. Incorrect installations of sealant are common, and can greatly decrease its useful life. Inspect sealant, more frequently as it ages, to determine if it is failing. Typical sealant problems include failure of sealant to adhere to adjacent materials and tearing/splitting of the sealant itself. As sealants age and are exposure to ultra-violet sunlight, they will dry out, harden, and lose their elastic ability. Remove and replace sealant as signs of failure begin to appear. Proper cleaning, prep work, and proper installation are critical for a long lasting sealant/caulking. Do not install sealant in locations that would block water drainage from behind the siding. Repair areas as needed prior to project. For best results, the client may want to consult with a building envelope specialist or waterproofing contractor to specify types of materials to be used and define complete scope of work before bidding. Best practice is to coordinate this type of work with other projects whenever practical, such as balcony sealing, planter waterproofing, etc.

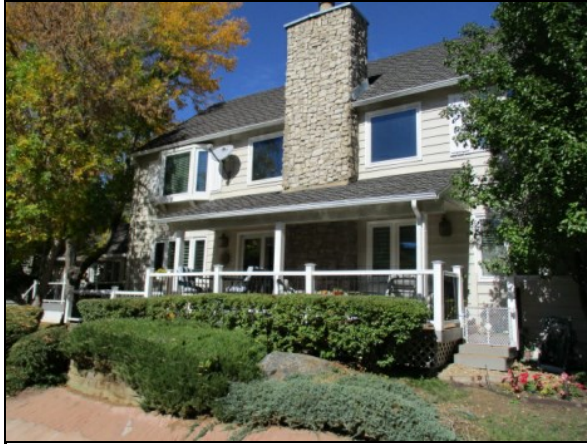
Comments: Client currently paints exteriors of residential units on an 8-year cycle. Components 23300-23308 include the funding for the paint cycles. Painted exterior surfaces determined to be in fair condition typically exhibit some minor to moderate signs of wear and age such as chalking peeling blistering etc. Problems tend to develop in more exposed areas first. Hairline cracks may be present at this stage. Overall appearance is satisfactory.

As routine maintenance, inspect regularly (including sealants), repair locally and touch-up paint as needed. Typical paint cycles can vary greatly depending upon many factors including type of material painted, surface preparations, quality of material, application methods, weather conditions during application, moisture beneath paint, and exposure to weather conditions. Proper sealant/caulking is critical to preventing water intrusion and resulting damage to the building structure. Incorrect installations of sealant are common, and can greatly decrease its useful life. Inspect sealant, more frequently as it ages, to determine if it is failing. Typical sealant problems include failure of sealant to adhere to adjacent materials and tearing/splitting of the sealant itself. As sealants age and are exposure to ultra-violet sunlight, they will dry out, harden, and lose their elastic ability. Remove and replace sealant as signs of failure begin to appear. Proper cleaning, prep work, and proper installation are critical for a long lasting sealant/caulking. Do not install sealant in locations that would block water drainage from behind the siding. Repair areas as needed prior to project. For best results, the client may want to consult with a building envelope specialist or waterproofing contractor to specify types of materials to be used and define complete scope of work before bidding. Best practice is to coordinate this type of work with other projects whenever practical, such as balcony sealing, planter waterproofing, etc.

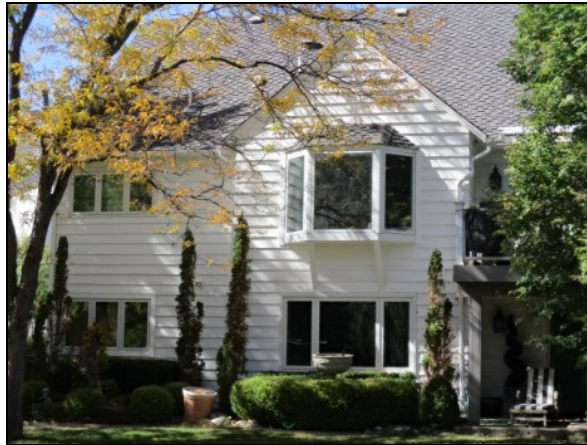
Comments: Client currently paints exteriors of residential units on an 8-year cycle. Components 23300-23308 include the funding for the paint cycles. Painted exterior surfaces determined to be in fair condition typically exhibit some minor to moderate signs of wear and age such as chalking peeling blistering etc. Problems tend to develop in more exposed areas first. Hairline cracks may be present at this stage. Overall appearance is satisfactory.

As routine maintenance, inspect regularly (including sealants), repair locally and touch-up paint as needed. Typical paint cycles can vary greatly depending upon many factors including type of material painted, surface preparations, quality of material, application methods, weather conditions during application, moisture beneath paint, and exposure to weather conditions. Proper sealant/caulking is critical to preventing water intrusion and resulting damage to the building structure. Incorrect installations of sealant are common, and can greatly decrease its useful life. Inspect sealant, more frequently as it ages, to determine if it is failing. Typical sealant problems include failure of sealant to adhere to adjacent materials and tearing/splitting of the sealant itself. As sealants age and are exposure to ultra-violet sunlight, they will dry out, harden, and lose their elastic ability. Remove and replace sealant as signs of failure begin to appear. Proper cleaning, prep work, and proper installation are critical for a long lasting sealant/caulking. Do not install sealant in locations that would block water drainage from behind the siding. Repair areas as needed prior to project. For best results, the client may want to consult with a building envelope specialist or waterproofing contractor to specify types of materials to be used and define complete scope of work before bidding. Best practice is to coordinate this type of work with other projects whenever practical, such as balcony sealing, planter waterproofing, etc.

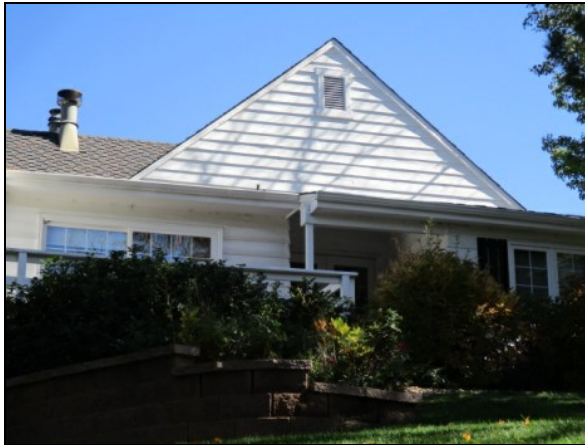
Comments: Client currently paints exteriors of residential units on an 8-year cycle. Components 23300-23308 include the funding for the paint cycles. Painted exterior surfaces determined to be in fair condition typically exhibit some minor to moderate signs of wear and age such as chalking peeling blistering etc. Problems tend to develop in more exposed areas first. Hairline cracks may be present at this stage. Overall appearance is satisfactory.

As routine maintenance, inspect regularly (including sealants), repair locally and touch-up paint as needed. Typical paint cycles can vary greatly depending upon many factors including type of material painted, surface preparations, quality of material, application methods, weather conditions during application, moisture beneath paint, and exposure to weather conditions. Proper sealant/caulking is critical to preventing water intrusion and resulting damage to the building structure. Incorrect installations of sealant are common, and can greatly decrease its useful life. Inspect sealant, more frequently as it ages, to determine if it is failing. Typical sealant problems include failure of sealant to adhere to adjacent materials and tearing/splitting of the sealant itself. As sealants age and are exposure to ultra-violet sunlight, they will dry out, harden, and lose their elastic ability. Remove and replace sealant as signs of failure begin to appear. Proper cleaning, prep work, and proper installation are critical for a long lasting sealant/caulking. Do not install sealant in locations that would block water drainage from behind the siding. Repair areas as needed prior to project. For best results, the client may want to consult with a building envelope specialist or waterproofing contractor to specify types of materials to be used and define complete scope of work before bidding. Best practice is to coordinate this type of work with other projects whenever practical, such as balcony sealing, planter waterproofing, etc.

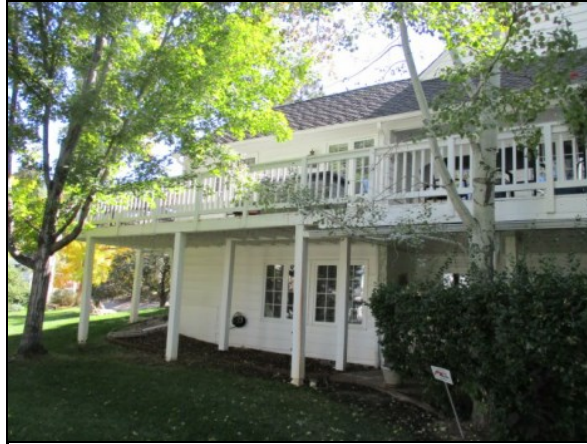
Comments: Client currently paints exteriors of residential units on an 8-year cycle. Components 23300-23308 include the funding for the paint cycles. Painted exterior surfaces determined to be in fair condition typically exhibit some minor to moderate signs of wear and age such as chalking peeling blistering etc. Problems tend to develop in more exposed areas first. Hairline cracks may be present at this stage. Overall appearance is satisfactory.

As routine maintenance, inspect regularly (including sealants), repair locally and touch-up paint as needed. Typical paint cycles can vary greatly depending upon many factors including type of material painted, surface preparations, quality of material, application methods, weather conditions during application, moisture beneath paint, and exposure to weather conditions. Proper sealant/caulking is critical to preventing water intrusion and resulting damage to the building structure. Incorrect installations of sealant are common, and can greatly decrease its useful life. Inspect sealant, more frequently as it ages, to determine if it is failing. Typical sealant problems include failure of sealant to adhere to adjacent materials and tearing/splitting of the sealant itself. As sealants age and are exposure to ultra-violet sunlight, they will dry out, harden, and lose their elastic ability. Remove and replace sealant as signs of failure begin to appear. Proper cleaning, prep work, and proper installation are critical for a long lasting sealant/caulking. Do not install sealant in locations that would block water drainage from behind the siding. Repair areas as needed prior to project. For best results, the client may want to consult with a building envelope specialist or waterproofing contractor to specify types of materials to be used and define complete scope of work before bidding. Best practice is to coordinate this type of work with other projects whenever practical, such as balcony sealing, planter waterproofing, etc.

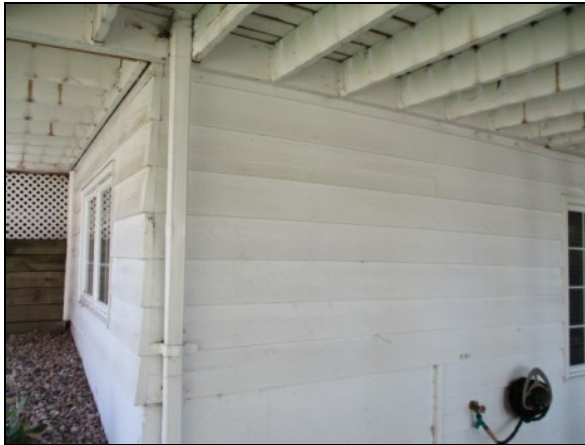
Comments: Client currently paints exteriors of residential units on an 8-year cycle. Components 23300-23308 include the funding for the paint cycles. Painted exterior surfaces determined to be in fair condition typically exhibit some minor to moderate signs of wear and age such as chalking peeling blistering etc. Problems tend to develop in more exposed areas first. Hairline cracks may be present at this stage. Overall appearance is satisfactory.

As routine maintenance, inspect regularly (including sealants), repair locally and touch-up paint as needed. Typical paint cycles can vary greatly depending upon many factors including type of material painted, surface preparations, quality of material, application methods, weather conditions during application, moisture beneath paint, and exposure to weather conditions. Proper sealant/caulking is critical to preventing water intrusion and resulting damage to the building structure. Incorrect installations of sealant are common, and can greatly decrease its useful life. Inspect sealant, more frequently as it ages, to determine if it is failing. Typical sealant problems include failure of sealant to adhere to adjacent materials and tearing/splitting of the sealant itself. As sealants age and are exposure to ultra-violet sunlight, they will dry out, harden, and lose their elastic ability. Remove and replace sealant as signs of failure begin to appear. Proper cleaning, prep work, and proper installation are critical for a long lasting sealant/caulking. Do not install sealant in locations that would block water drainage from behind the siding. Repair areas as needed prior to project. For best results, the client may want to consult with a building envelope specialist or waterproofing contractor to specify types of materials to be used and define complete scope of work before bidding. Best practice is to coordinate this type of work with other projects whenever practical, such as balcony sealing, planter waterproofing, etc.

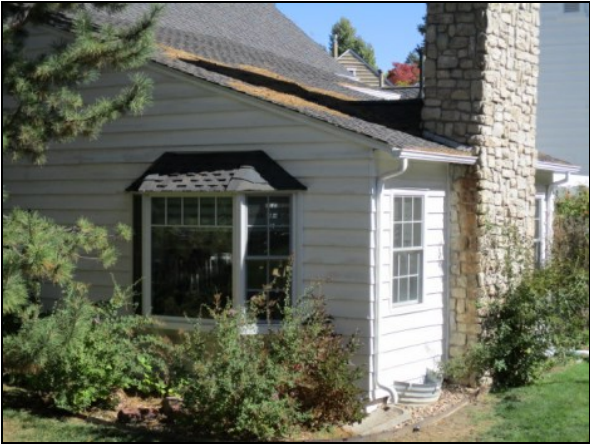
Comments: Component funds for the need for a second coat of paint in any current year phase. Due to solar patterns, tree coverage, and other environmental factors, some buildings or sides of buildings need a second coat of paint in order to bolster coverage. Client currently paints exteriors of residential units on an 8-year cycle. Components 23300-23308 include the funding for the paint cycles. Painted exterior surfaces determined to be in fair condition typically exhibit some minor to moderate signs of wear and age such as chalking peeling blistering etc. Problems tend to develop in more exposed areas first. Hairline cracks may be present at this stage. Overall appearance is satisfactory.

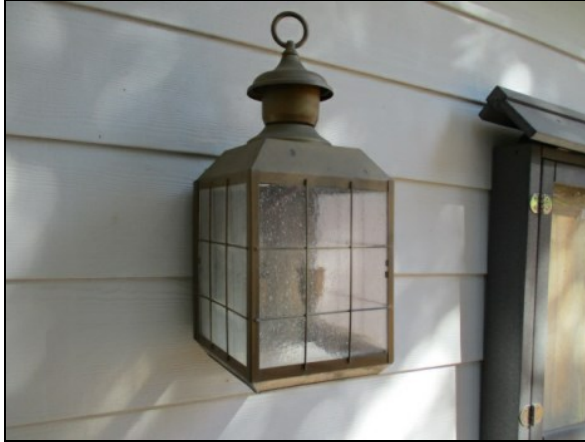
Comp #: 23020 Clubhouse Lights - Replace

Comments: Exterior lights determined to be in fair condition typically exhibit more moderate signs of wear and age but are generally believed to be aging normally with no unusual conditions noted. Observed during daylight hours but assumed to be in functional operating condition. As routine maintenance clean by wiping down with an appropriate cleaner change bulbs and repair as needed. Best practice is to plan for replacement of all lighting together at roughly the time frame below for cost efficiency and consistent quality/appearance throughout development. Should be coordinated with exterior painting projects whenever possible. Individual replacements should be considered an Operating expense. If available an extra supply of replacement fixtures should be kept on-site to allow for prompt replacement.

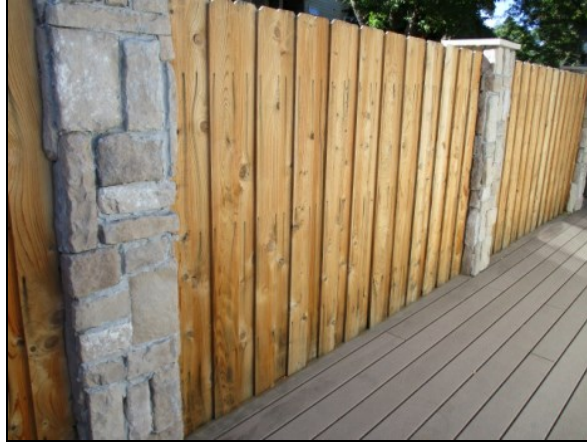
Comp #: 28020 Pool Fence - Repair/Paint

Comments: Wood fencing determined to be in good condition typically exhibits a uniform coating or surface finish with only minor deterioration or color fading. Appearance is consistent over most/all areas and has good curb appeal. Regular uniform, professional paint or sealer applications are recommended for appearance, protection of wood and maximum design life. Repair as needed and clean prior to application. Plan for regular applications as shown below. Timing of repair/paint cycles may need to be coordinated with eventual fence replacement.

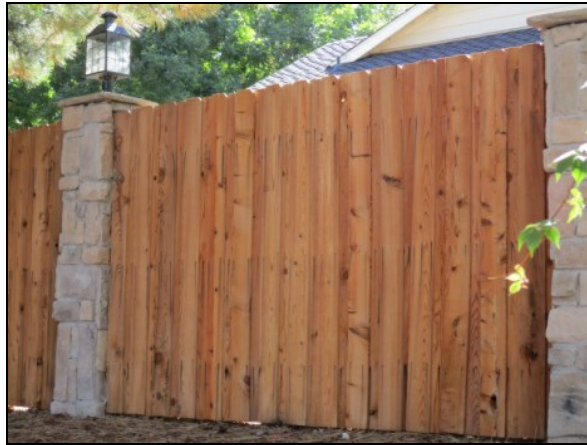
Comp #: 28030 Pool Fence - Replace**Quantity: ~ 280 LF**

History: Pool fence replaced in 2020.

Comments: Wood fencing determined to be in good physical/structural condition is stable and upright, with no signs or reports of damage or required repairs. All components and hardware appear to be in serviceable condition with no unusual or advanced signs of wear or age. Fencing is in good aesthetic condition. As routine maintenance, inspect regularly for any damage, repair as needed and avoid contact with ground and surrounding vegetation wherever possible. Regular cycles of uniform, professional sealing/painting will help to maintain appearance and maximize life. In our experience, wood fencing will typically eventually break down due to a combination of sun and weather exposure, which is sometimes exacerbated by other factors such as irrigation overspray, abuse and lack of preventive maintenance. Recommendation and costs shown here are based on replacement with similar style and material. However, the Association might want to consider replacing with more sturdy, lower-maintenance products like composite, vinyl, etc. Although installation costs are higher, total life cycle cost is lower due to less maintenance and longer design life expectancy.

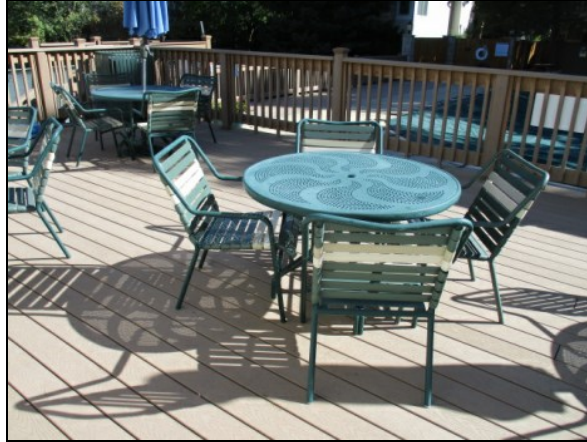
Comp #: 28040 Pool Deck Furniture - Replace**Quantity: ~ (72) Pieces**

History: Planned for replacement in 2022 for ~\$20,000.

Comments: Includes (33) Chairs, (21) Chaise Lounges, (5) Tables, (4) Umbrellas, (9) Drink Tables. The furniture appeared in generally poor condition. Furniture and decor appeared to be older and outdated. Plan to update soon. We recommend regular inspections and repair or replacement of any damaged pieces promptly to ensure safety. Protected storage of furniture when not in use can help to extend useful life. Best practice is to replace all pieces together in order to maintain consistent style and quality in the pool/recreation area. Costs can vary greatly based on type of pieces selected for replacement. Funding recommendation shown here is based on replacement with comparable number and quality of pieces.

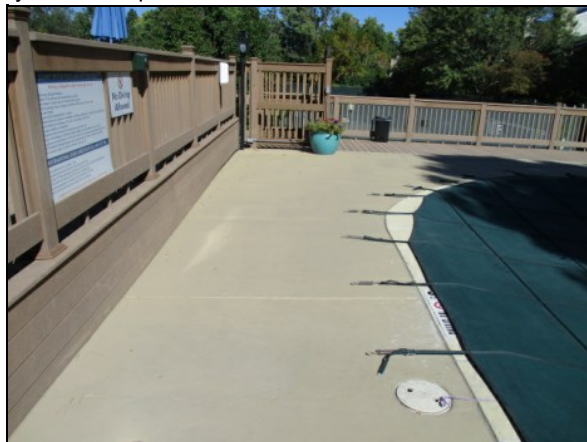
Comments: Decking was observed to be in fair condition. The concrete surfaces exhibited hairline cracking shrinkage and settlement cracking. These issues can result in water entry to the base which can ultimately lead to trip hazards. Pool decks may be exposed to harsh chemicals that can leave stains if not addressed properly. Periodic pressure-washing and re-coating will restore the appearance and prolong the need for major restoration or replacement of the deck surface. Take note of any places where water is ponding which may result in slip-and-fall hazards if not corrected.

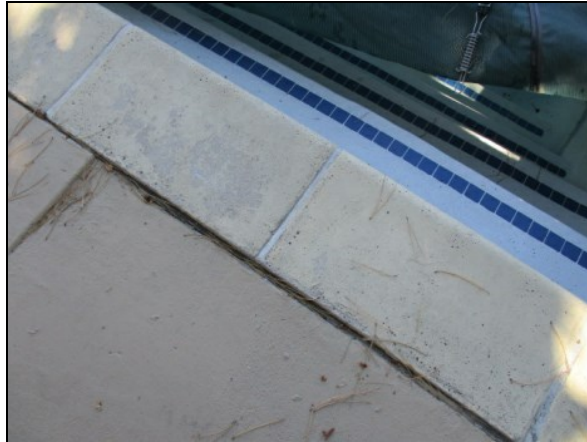
Comp #: 28090 Coping Stones - Repair**Quantity: ~ 230 LF**

Comments: Coping stones were observed to be in fair condition. The surfaces exhibited minor hairline cracking and with some shrinkage and settlement cracks observed which can result in water entry to the base which can ultimately lead to trip hazards. Although complete replacement of all areas together should not be required conditions observed merit inclusion of an allowance for ongoing repairs and partial replacements. Exposure to sunlight weather and frequent vehicle traffic can lead to larger more frequent repairs especially for older properties. Inspect all areas periodically to identify trip hazards or other safety issues. Timeline and cost ranges shown here should be re-evaluated during future Reserve Study updates.

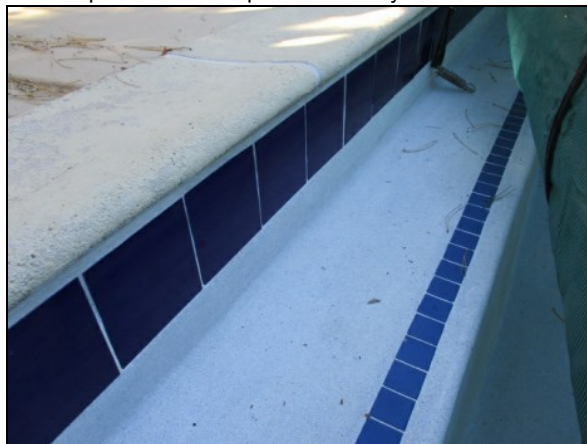
Comments: Pool/Spa was observed to be in fair condition. Pavers exhibited minor cracking. Appearance was noted to be upholding appropriate aesthetic standards for the property. Small repairs to waterline tile should be done as needed as an Operating expense. Complete re-tiling is warranted at longer intervals to restore the look and feel of the interior finish. While drained for resurfacing, any other repairs to lighting, handrails, stairs, ladders, etc. should be conducted as needed. This type of project is best suited for slow/offseason to minimize downtime during periods when pool is used heavily. Should be expected at the approximate interval shown below to preserve this important amenity of the association.

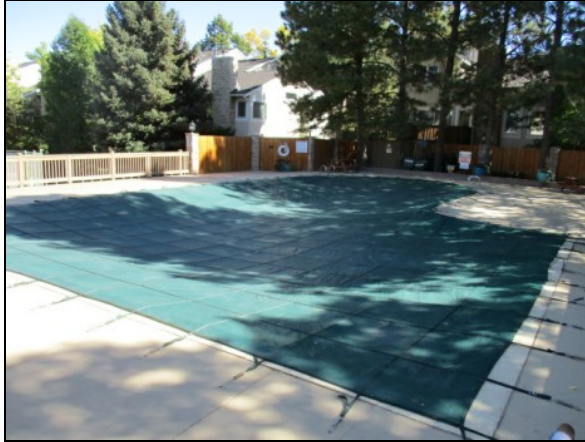
Comments: Pool surfaces exhibited some pitting chipping un-even and broken surfaces. Cracks were observed to be substantial. Pool resurfacing will restore the aesthetic quality of the pool while protecting the actual concrete shell of the pool from deterioration. While drained for resurfacing any other repairs to lighting handrails stairs ladders etc. should be conducted as needed. This type of project is best suited for slow/offseason to minimize downtime during periods when pool is used heavily. Should be expected at the approximate interval shown below in some cases schedule may need to be accelerated due to improper chemical balances or aesthetic preferences of the client.

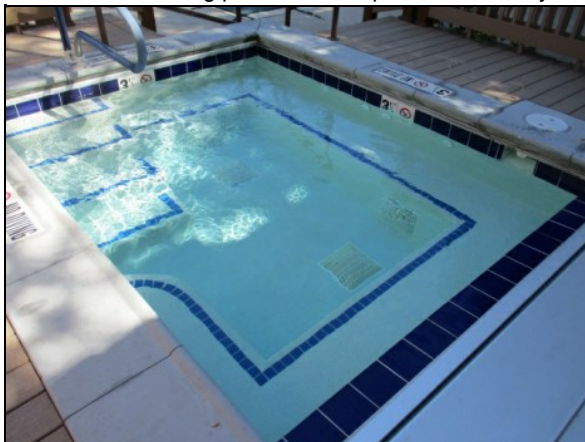
Comments: Spa surfaces exhibited minimal, pitting chipping, and un-even and broken surfaces. Cracks were not observed to be substantial. Spas sometimes need to be resurfaced more frequently than pools due to higher chance of chemical imbalances. Whenever possible both should be done at the same time to achieve better pricing and minimize downtime. While drained for resurfacing any other repairs to lighting handrails stairs ladders etc. should be conducted as needed. This type of project is best suited for slow/offseason to minimize downtime during periods when spa is used heavily.

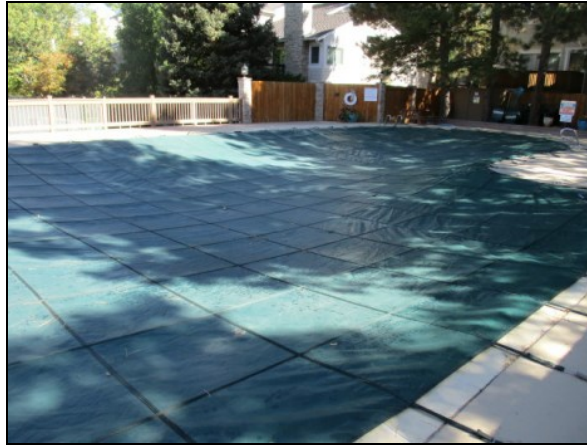
Comp #: 28140 Pool Cover - Replace**Quantity: ~ (1) Cover**

Comments: Cover was observed to be in poor condition. Fabric was noted to be faded with ripping observed. Inspect regularly and properly store when not in use. Cover can provide cost savings for temperature differentials reduce cleaning costs and provide safety. We suggest planning to replace at regular intervals to maintain proper functionality.

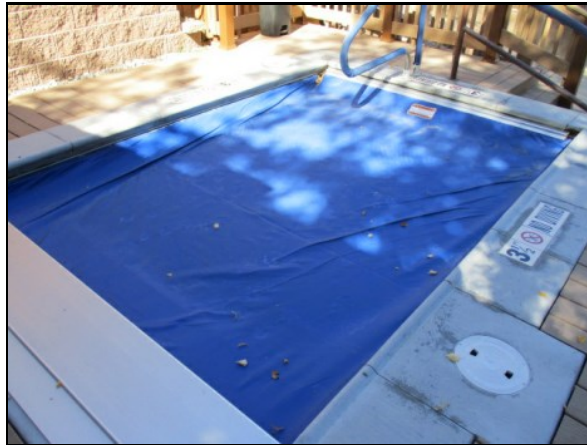
Comp #: 28150 Spa Cover - Replace**Quantity: ~ (1) Cover**

History: Replaced in 2021.

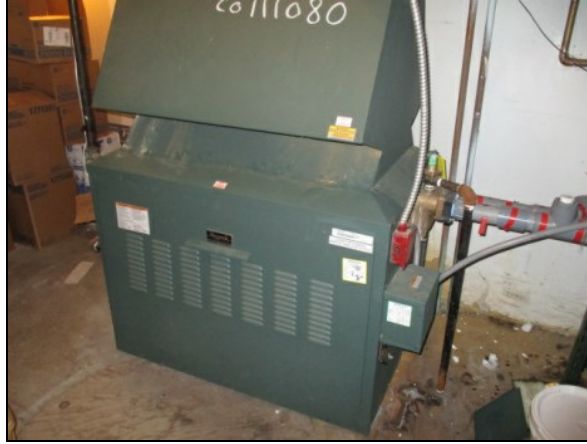
Comp #: 28170 Pool Heater - Replace

History: Replaced in 2017.
